CASE SERIES

Pitfalls due to improper positioning of Impella[®]CP device for left ventricular support: a case series

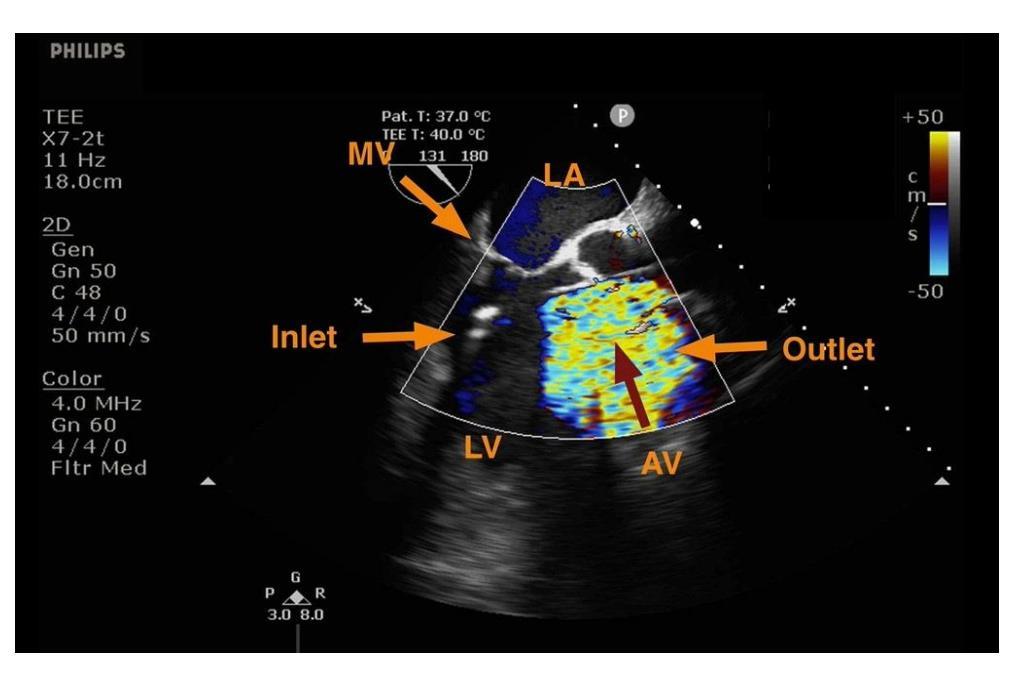
Figure 1: Improper positioning of the Impella catheter, as it was inserted more than 4.5 cm below the aortic valve. Additionally, a transesophageal echocardiogram (TEE) revealed turbulent flow with a dense mosaic pattern beneath the aortic valve when the catheter outlet area crossed the valve.

In patient 1 and 3, there was troubleshooting position alarm and low flow rate than expected, which confirmed by TEE as incorrect Impella catheter placement. In patient 1, the catheter inlet area was located more than 4.5 cm below the aortic valve (Figure 1). In patient 3, the catheter was too close to the heart wall.

Improper positioning may result in a limited flow rate or even loss of mechanical support. Therefore, it is mandatory to verify the proper positioning of the catheter by using TEE and waveform characteristics on the control unit screen. In a previous case report, it was depicted that the catheter's inlet area was improperly positioned in the aorta.⁵ Similarly, in one of our cases, we found that the inlet area was too far from the aortic valve.

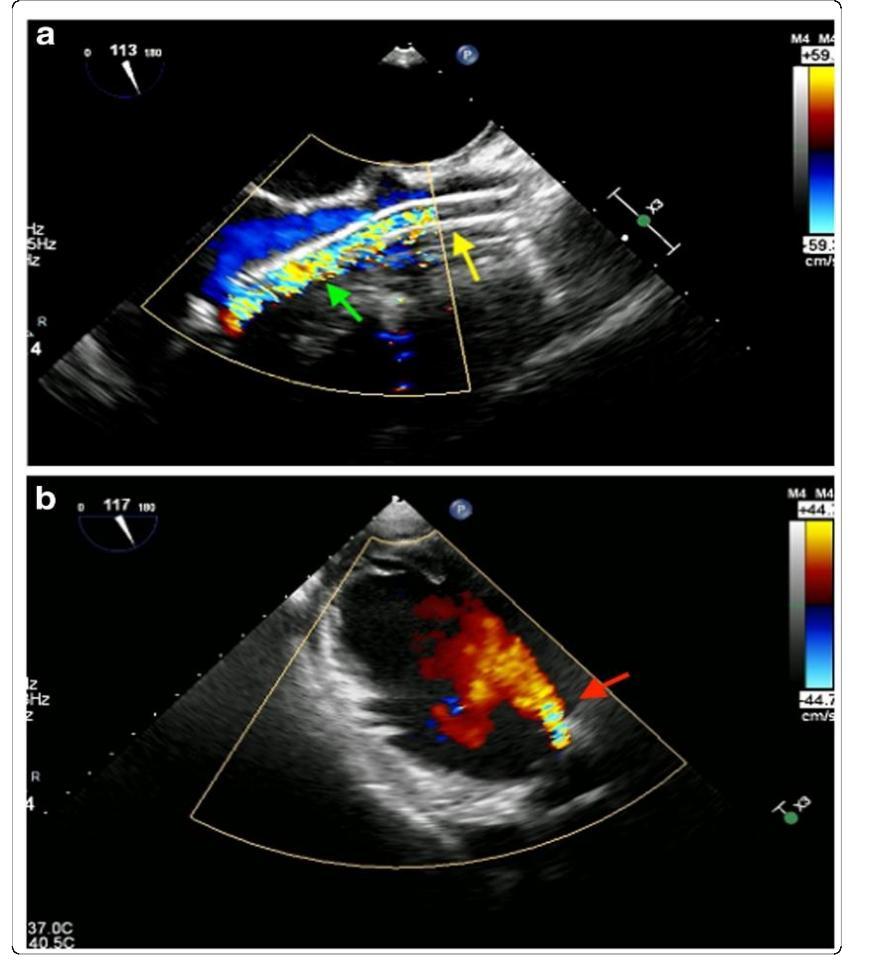
Figure 2 (a):

Transesophageal echocardiography (midesophageal long-axis view). The Impella cannula is denoted by the yellow arrow, while the artifacts are indicated by the green arrow. The presence of axial blood flow-related artifacts reverberation within the Impella device made it difficult to accurately diagnose aortic insufficiency using transesophageal echocardiography.

(b): Deep trans gastric view. The regurgitation jet, which resulted from aortic insufficiency, is indicated by the red arrow. This view presented a clear identification without any artifacts.

aortic insufficiency. In Patient 1, the Impella consol indicated 5.0 L/min is the anticipated flow rate when the Impella device was operating at its highest level of assistance. Nevertheless, the cardiac output measured through a pulmonary artery catheter was observed to be 3.5 L/min. TEE revealed the presence of recently formed AI subsequent to the insertion of Impella (Figure 2a, 2b). This finding suggested that the reduction in cardiac output by 1.5 L/min could be attributed to the volume of AI. Likewise, patients 2, 3, and 4 exhibited CCO that was more than 1 L/min below the anticipated flow indicated on the Impella console, indicating the presence of newly formed aortic insufficiency.

flow within the Impella device, accurate identification of aortic insufficiency was challenging by TEE for patient 1 (Figure 2a). Precise diagnosis of aortic insufficiency required careful observation with different views. It was clearly observed on the deep transgastric view as it was distinctly identified (Figure 2b)
